National Aeronautics and Space Administration

Nuclear Compton Telescope Balloon Launch in Alice Springs, Northern Territory, Australia

High Visibility Type B Mishap

IRIS Case Number S-2010-119-00007

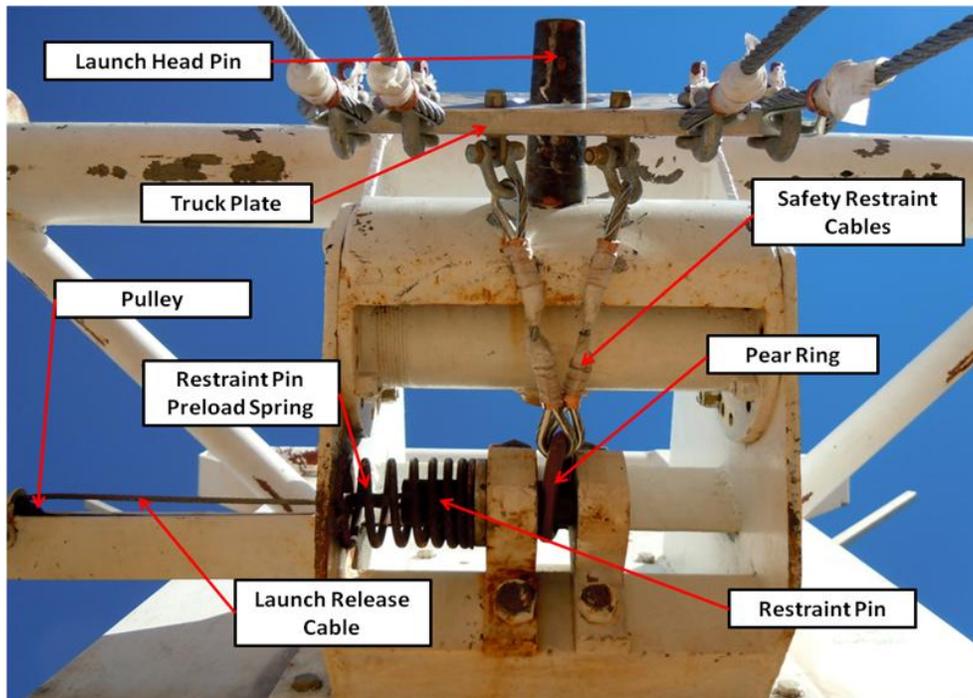
Figure C1-3. Annotated View From Under Launch Head

It was noted during pre-test observations that the restraint pin was not well lubricated and felt relatively 'dry' to the touch. This was also true of the pulley used to redirect the cable from the release pin to the fulcrum.

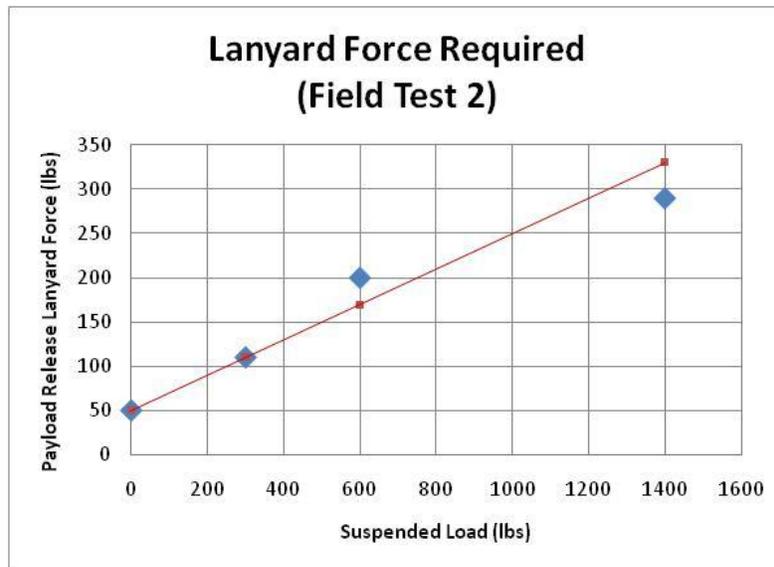
Figure C1–13. Modeled (in red) and Measured (blue diamonds) Lanyard Force vs Pear Ring Load

A simple analysis of the force transfer appears to be consistent with the test results. Figure C1–13 repeats the test data with the addition of predicted lanyard forces assuming that the fulcrum advantage is 3:1 and that the effective coefficient of friction between the pear ring and the restraint pin is 0.60. This coefficient of friction is consistent with kinetic friction between two non-lubricated pieces of steel. In this system there are also some losses in the pulley and at the eyebolt that also is proportional to the total load.

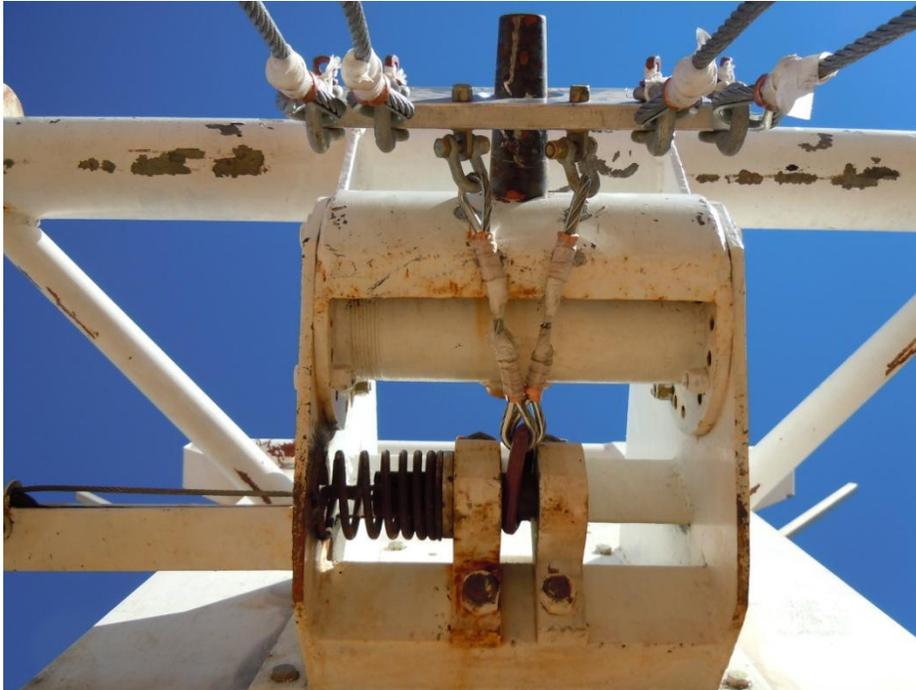
Figure C1–15. Position of the Truck Plate and Restraint Cables When Pulled Forward

Significance of the test: During launch operations, if the net upwards force on the truck plate is applied at an angle forward of normal to the bottom of the launch pin, a component of that force will be carried by the restraint cables and pear ring into the restraint pin. The purpose of the restraint hardware is to prevent the truck plate from coming free from the launch pin before it is desired. A concomitant result is that normal (or shear) loading on the restraint pin is a factor of the various forces on the cable ladder introduced by the buoyant and aerodynamic forces on the balloon and by the gondola. A forward angle (balloon ahead of the launch vehicle) of the flight train loading tends to pull the truck plate away from the launch head and toward the end of the launch pin. (See Figure C1-15)

This action extends the restraint cables and loads the restraint pin. Generally, the greater the forward angle, the greater part of the force is reacted at the restraint pin.

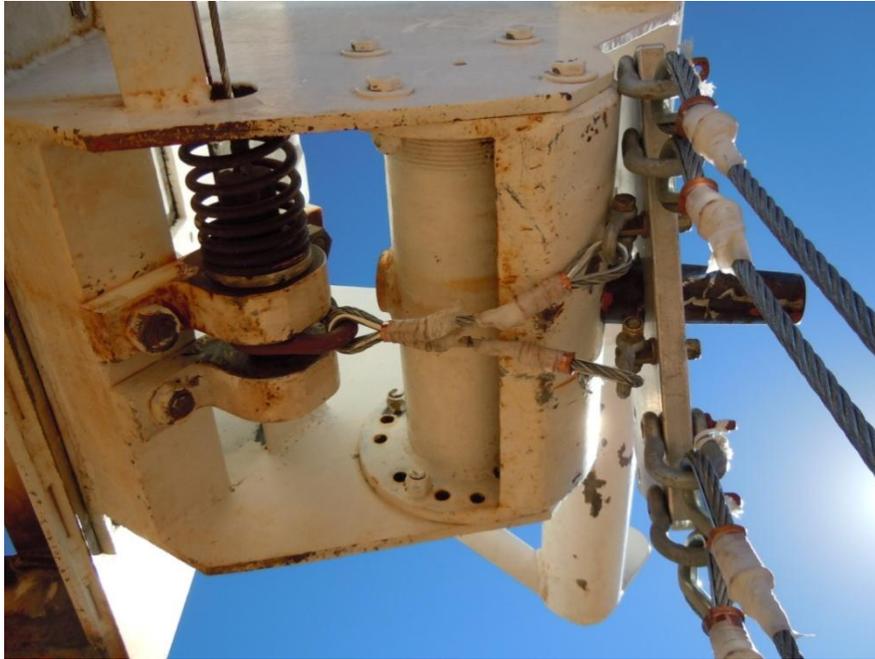
Figure C1-16. Truck Plate Twisted by a Manually Applied Force

In addition, a sideward angle has the effect of lifting the nearer (to the direction of the load) corner of the truck plate and twisting the truck plate such that the nearer restraint cable is loaded due to the twisting action of the truck plate. (See Figure C1–16) The safety restrain cable on the low end of the truck plate is unloaded. The test was intended to quickly assess the possible individual and combined effects of these two loading conditions.

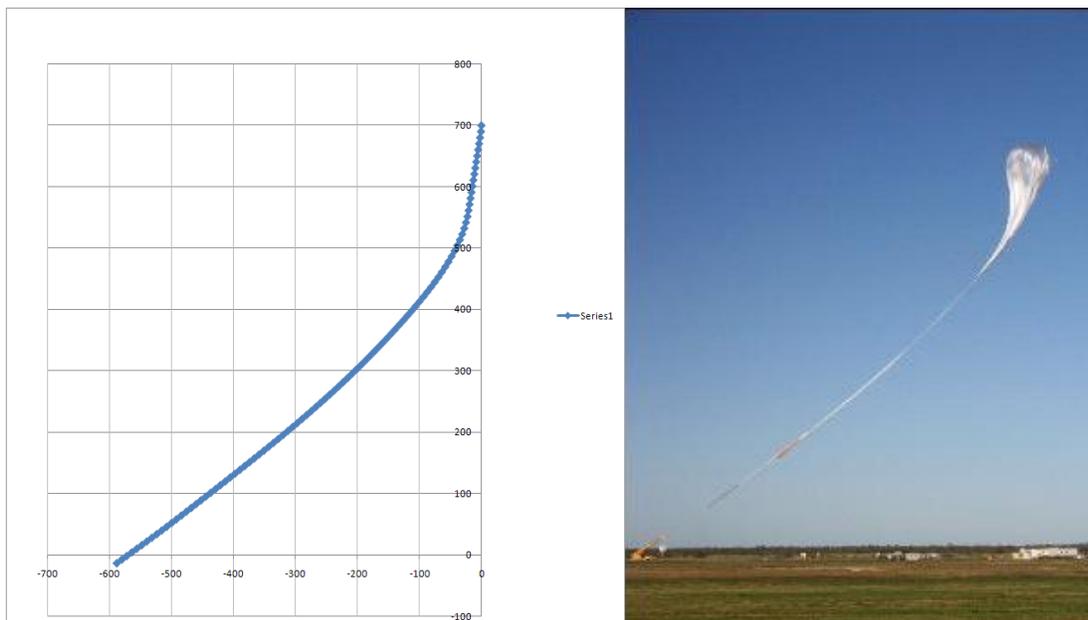
Figure C2-2. Catenary Analysis of the NCT Flight Train

The catenary Steady State Equilibrium (Static) analysis for the crane positioned at the Airport fence solution produced a reasonable geometric fit with the photographic evidence as is shown in figure C2-2. The necessary forces at the truck plate to support the system weight and drag through the catenary were calculated to be approximately 9280 lbs. at approximately 38 degrees from horizontal. Matching the observed catenary required a drag adjustment factor of about 0.65 resulting in a total horizontal drag force of about 7300 lbs.

At the fence condition, the results of the independent Dynamic Analysis confirm the estimated horizontal drag force to be about 7200 lbs and the flight train angle with the horizontal at the crane to approximately 38 degrees. The total load at the crane head for this analysis is 9300 lbs.

A simple check can be accomplished by resolving the net vertical force (lift – weight) in the system along the known ladder angle at the crane head. The angle is determined from the photo evidence to be about 38 degrees. Resolving the net 5745 lbs along this angle gives a necessary total reactive force of 9350 lbs.

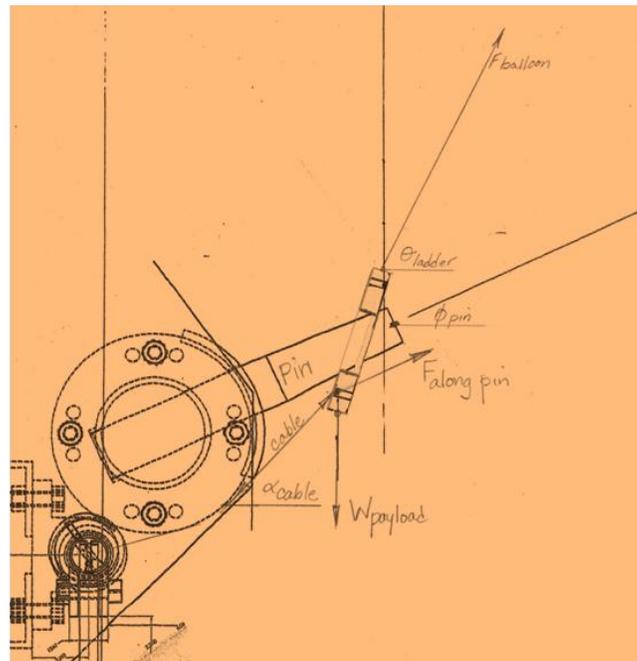
Figure C2-7. Launch Head Pin, Restraint Cable and Truck Plate Sketch

From photographic evidence, the forward angle at the launch attempt appears to be about 10 to 12 degrees (78 - 80 degrees from horizontal). The effective angle of the launch head pin from the horizontal was a function of the crane boom angle, the launch head pin angle within the launch head assembly and the launch head pin taper. This effective angle is approximately 25 degrees from the horizontal, but is in practice dynamic, changing as the crane moves over the terrain. At this angle, the load in the safety restraint cables after resolving the force along the launch head pin is reduced to about 60% of the load in the flight train. (For reference see Figure C2-7 below) The analysis assumes no appreciable reduction due to friction. This is a reasonable approximation since the truck plate/launch head pin normal forces are relatively small since the truck plate sees the force difference between the payload weight and the upward flight train loads. Preliminary calculations showed force modifications on the safety restraint cables due to friction to be on the order of 200 lbs. The remainder of the ladder force on the truck plate is reacted in the pin in shear and bending. The static catenary analysis shows a total flight train force introduced into the truck plate of about 6000 lbs. The resulting total force in the safety restraint cable pair is then about 1500 lbs after allowing for the offset due to the payload weight (4787 lbs), reacted at the bottom of the truck plate. For comparison, the dynamic analysis shows a total force of about 6900 lbs and a slightly higher force on the restraint cable pair.

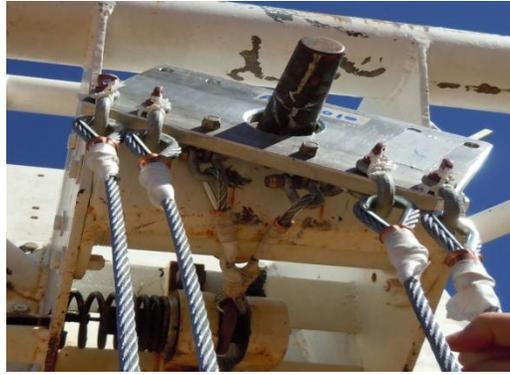
Figure C2-10. Illustration of Twisted Truck Plate

At the time of the unintended release from the launch head pin, the crane was headed generally in an anti-wind direction at several feet per second which would have generated ladder forces greater than 10,000 lbs and less than 12,000 lbs. This results in restraint cable forces (in the pair) of 7,000 to 8,000 lbs. In addition, loads produced by the pendulous motion of the payload would add to these forces to produce the maximum forces at the time. The process of turning the launch vehicle away from the downwind direction also changed the way the loads were introduced into the truck plate. Ground testing after the incident showed that side loads introduced through the flight train caused the truck plate to rotate about the launch head pin. This rotation of the truck plate in turn prevents the load from being carried symmetrically by the restraint cables. (See Figure C2-10)

For extensive rotation which would be produced by the configuration at cable rupture, one cable is essentially relieved of force and the entire load is carried by a single cable. Therefore, there was enough load reacted at the truck plate to rupture the single loaded cable assembly carrying the predominance of the load. The second cable assembly would then be subjected to the total local load and would also rupture. The ultimate ratings of the eyebolt that ruptured (after considering the bending loads produced as it was employed) and the cable that ruptured are both less than the predicted load.

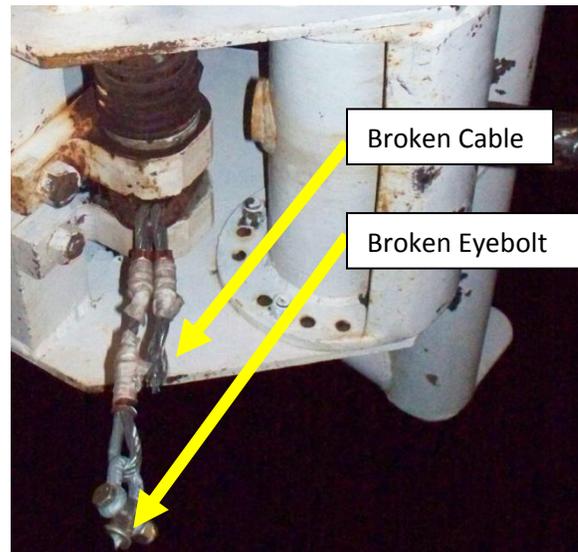
Figure C2-11. Illustration of Broken Cable and Broken Eyebolt

The estimated forces produced at the time of the inadvertent release are entirely consistent with the rupture of the restraint cables. The cables likely rupture one at a time as the load was carried first by one, then the next cable. (See Figure C2-11 below)

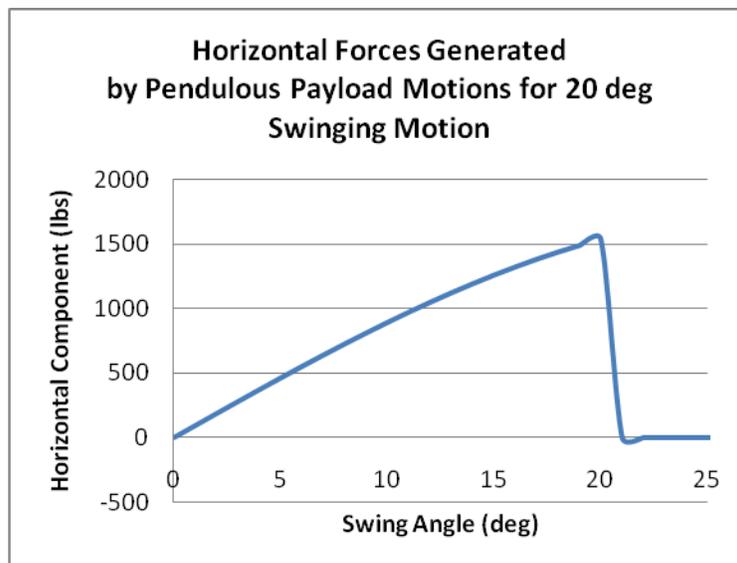
Figure C2-12. Potential Horizontal Forces Produced by Payload Pendulous Motions

For the launch conditions here, peak angular amplitudes were observed to 20 degrees, which can produce horizontal forces up to 1400 lbs. (See Figure C2-12 below) It is extremely challenging to determine the angular position of the gondola at the times of attempted lanyard pull.

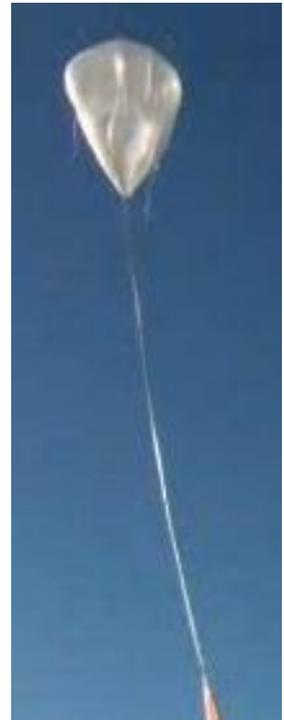
C2-13. Balloon with Collar

The drag areas were determined based on photographic evidence of the balloon just prior to the collar release. (See Figure C2-13) In this condition, the drag area is somewhat less than that observed after the collar release. The new drag area was used with the same effective drag coefficient that was shown to cause analysis agreement with both the overall catenary shape and terminal angle at the launch head.

Application of the same static analytical technique yielded an ultimate force at the launch head of approximately 8000 lbs with the collar compared to 10000 lbs without the collar. The resulting angle with the horizontal is calculated to be closer to 50 degrees with the collar as compared to about 47 degrees without it. Applying an approximate 80% reduction would put the safety restraint cable forces between 5500 and 6500 lbs.

Maintaining the collar until after pin release would have reduced the cable load on the safety restraint cables. The loads are predicted to be reduced to a point where, if one neglects potential pendulous payload dynamics loads or wind gust loads, the restraint cables may not have ruptured at the time. However, consideration of these additional loads creates a situation that may still have led to cable rupture

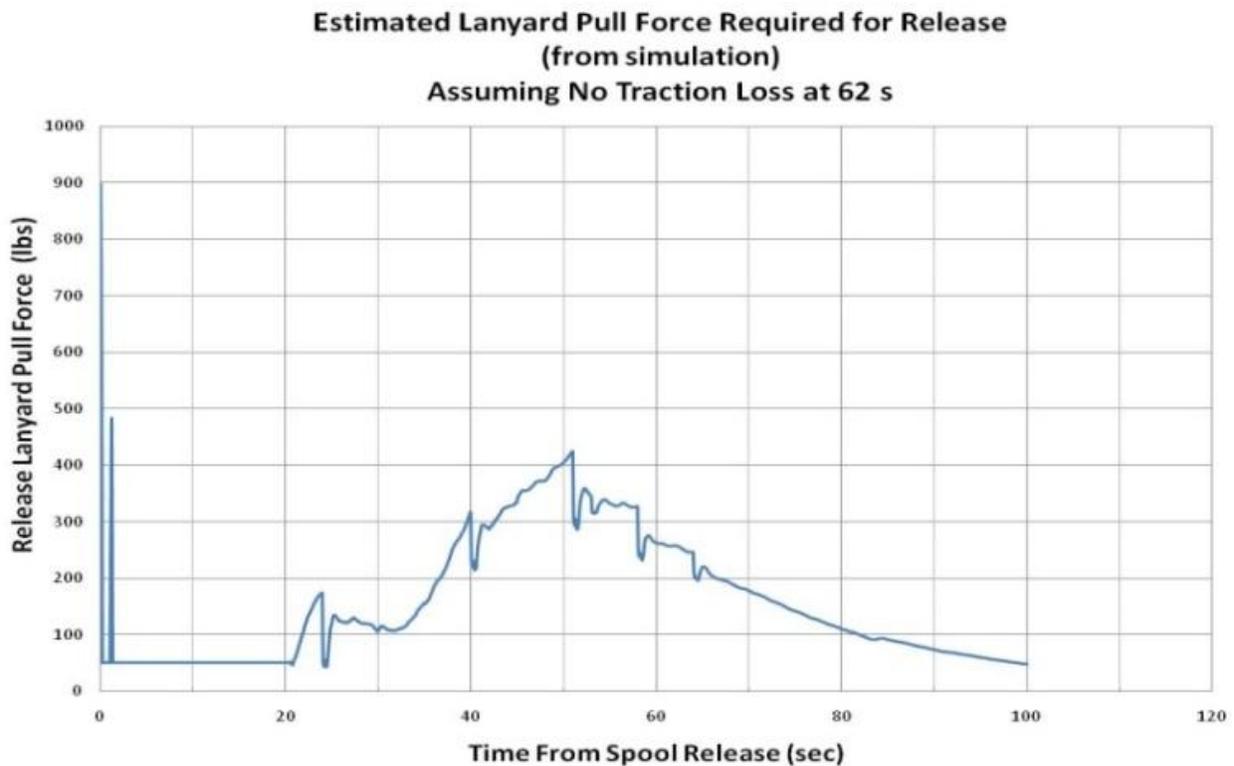
Figure C2-14. Estimated Lanyard Release Force for Hypothetical Case of No Traction Loss and Improved Driving Direction

Given slightly different conditions, even with the wide right turn that was executed, it is predicted that the NCT launch was possible with the vehicle and hardware compliment that existed. It should be noted that the launch vehicle would have been out of the Category A Hazard Area.
