National Aeronautics and Space Administration

Nuclear Compton Telescope Balloon Launch in Alice Springs, Northern Territory, Australia

High Visibility Type B Mishap

IRIS Case Number S-2010-119-00007

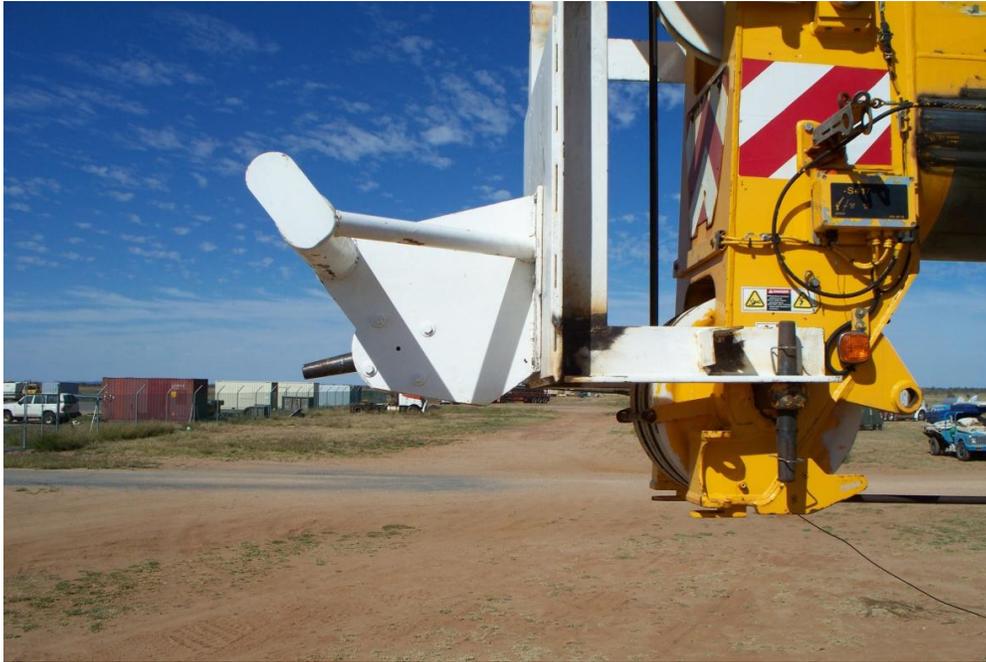
Figure C1-1. Launch Head Mounted to Crane

Test Set Up and Procedure (As Run): The crane and launch head were used in their unchanged flight conditions. The crane boom was positioned in the transportation position (horizontal) rather than in the raised launch condition. This configuration is shown below.

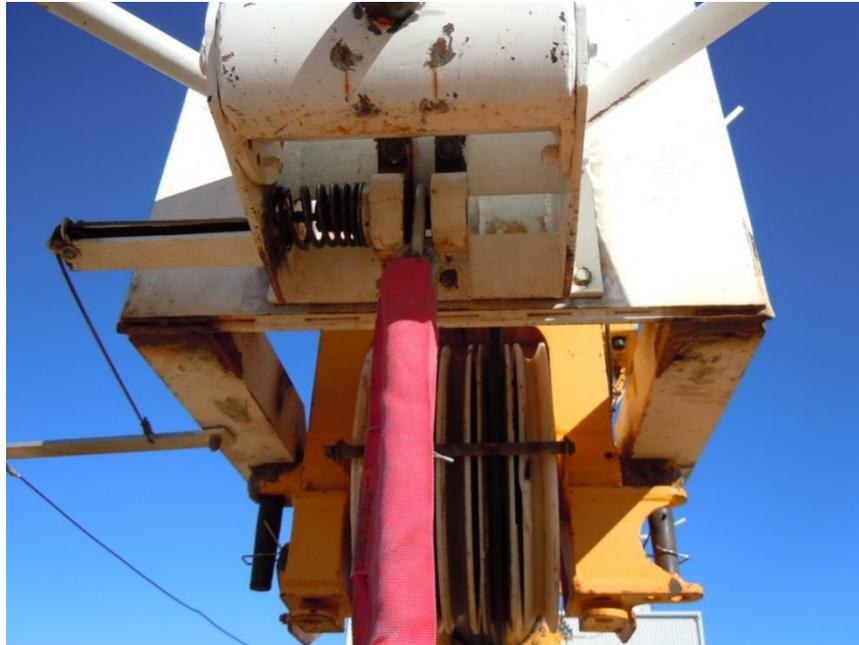
Figure C1-5. Test Configuration with Loading Hardware

A new pear ring with a lift strap was placed in the restraint mechanism over the pin within the pin block in the same way as the pear ring is captured during operations. (See Figures C1-5 and C1-6). Premeasured loads of 300, 600 and 1400 pounds were suspended. The 300 and 600 pound loads were hook and pulley blocks and the 1400 pound load was a concrete block.

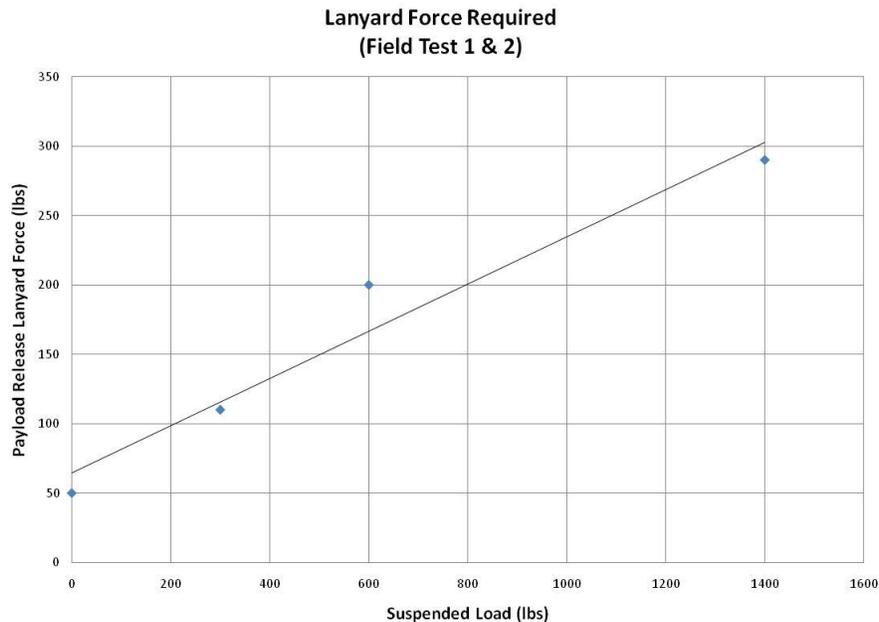
Figure C1-12. Field Tests 1 & 2 Results: Direct Loading of Restraint Pin with Least Squares Best Fit Line

Suspended Load	Units	Lanyard Force Required	Units	Uncertainty
0 lb		47 lb		+/- 5 lbs
0 lb		54 lb		+/- 5 lbs
0 lb		50 lb		+/- 5 lbs
300 lb		110 lb		+/- 10 lbs
600 lb		200 lb		+/- 10 lbs
1400 lb		290 lb		+/- 10 lbs

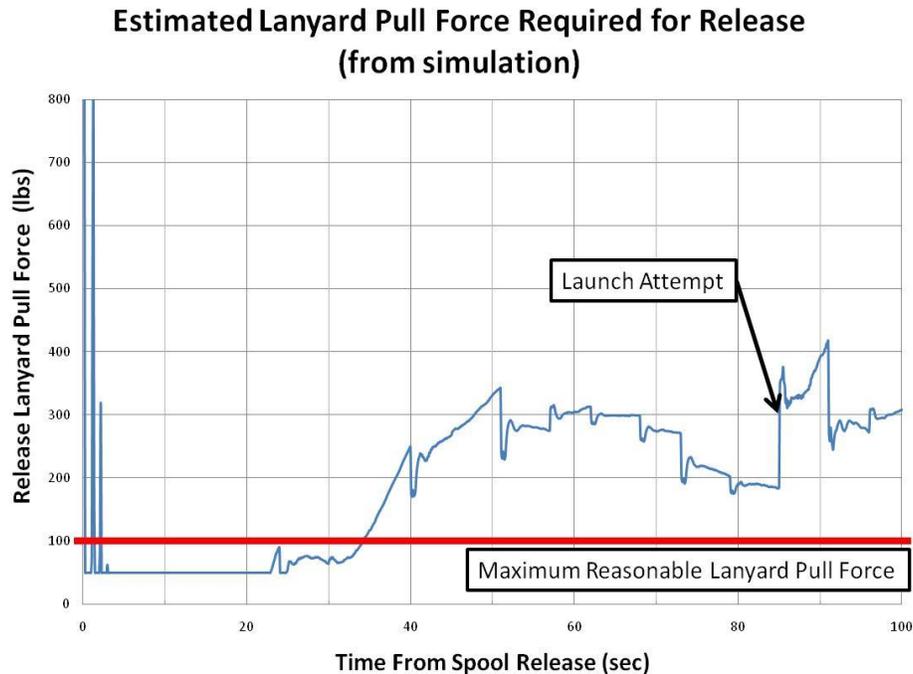
Figure C2-9. Estimated Release lanyard Pull Force vs Time Estimates from Dynamic Simulation

Lanyard force models developed from the Field Test results were coupled with the dynamic model to estimate the pull force throughout the launch timeline. These results are presented in Figure C2-9. Note that pull force is predicted to change quite abruptly at about 86 seconds when the launch vehicle slows for the attempt. This is consistent with the inertial and increased drag loading of the balloon system as the launch vehicle slows. The implication is that an attempt just prior to slowing is predicted to take about 200 lbs, where just after it decelerates is increased to over 300 lbs. The dynamic analysis is consistent with the static analysis regarding the lanyard pull force.
